Limited Visual Dam Safety Inspection Summary Report

MA-132

Puukoa Reservoir

May 2006

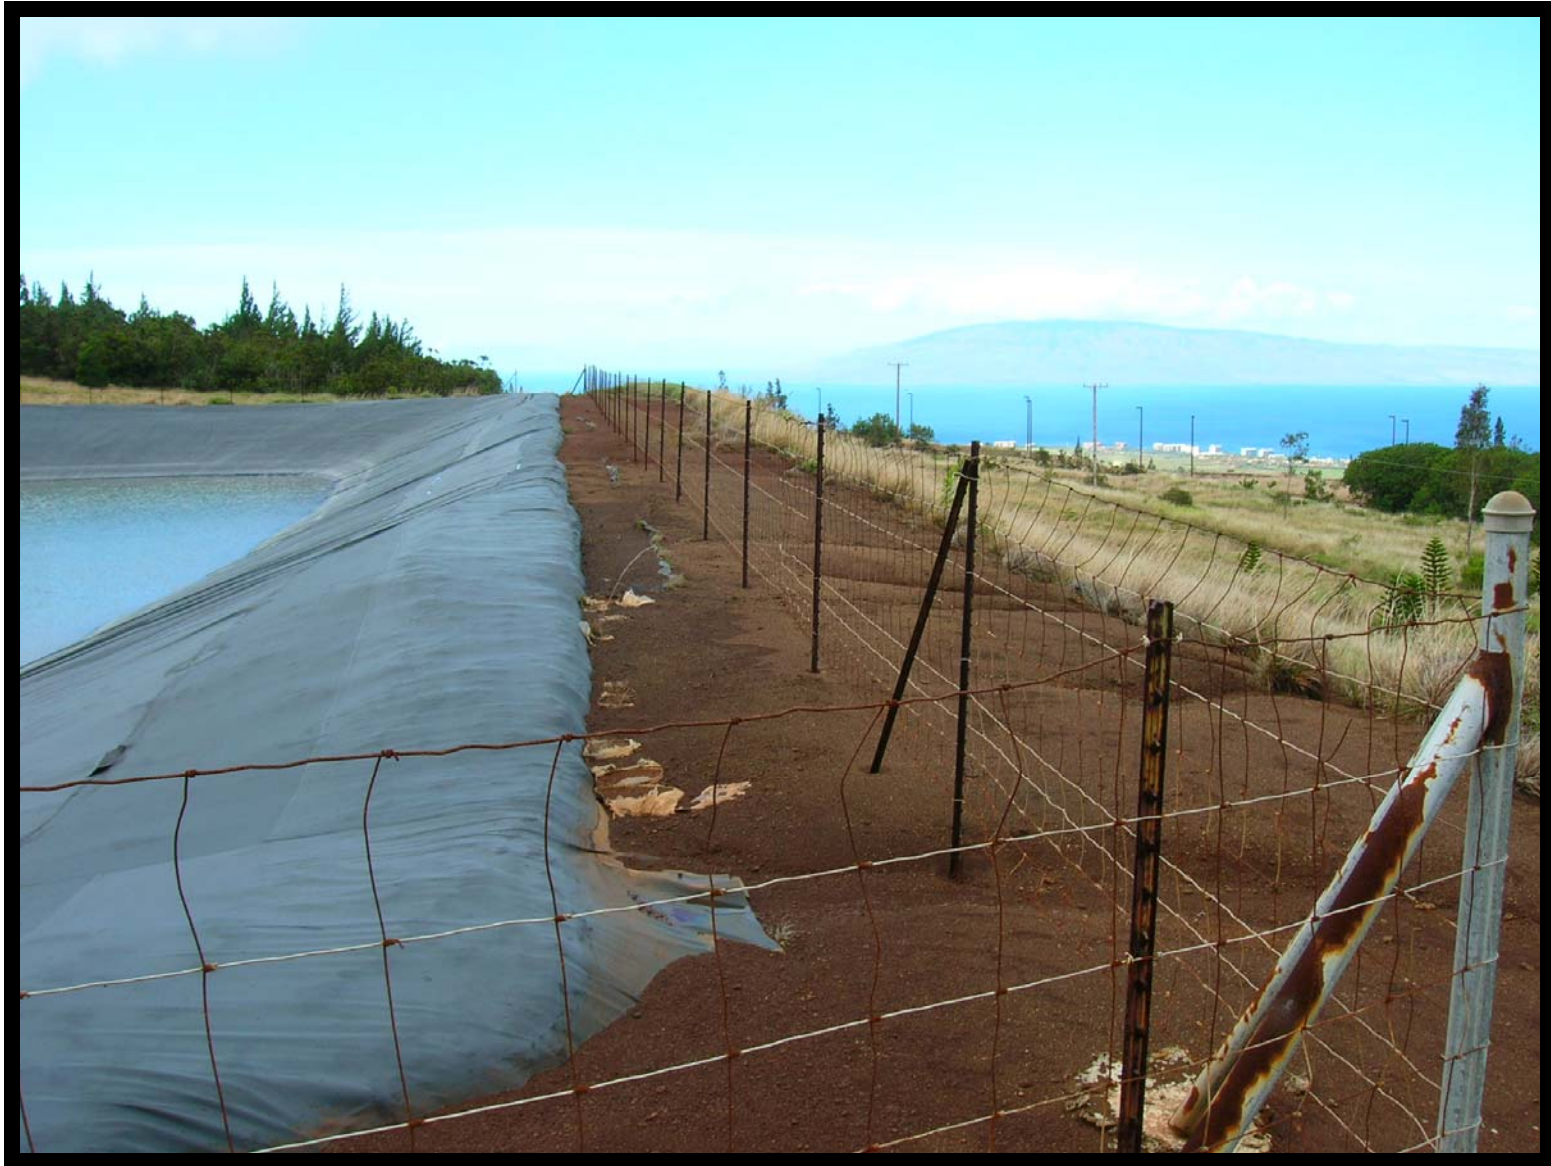
132 crest

Cracks, sinkholes and erosion were not observed.

- a. Access along the crest was satisfactory.
- b. The dam crest appeared to be in satisfactory condition, no corrective actions are required at this time.

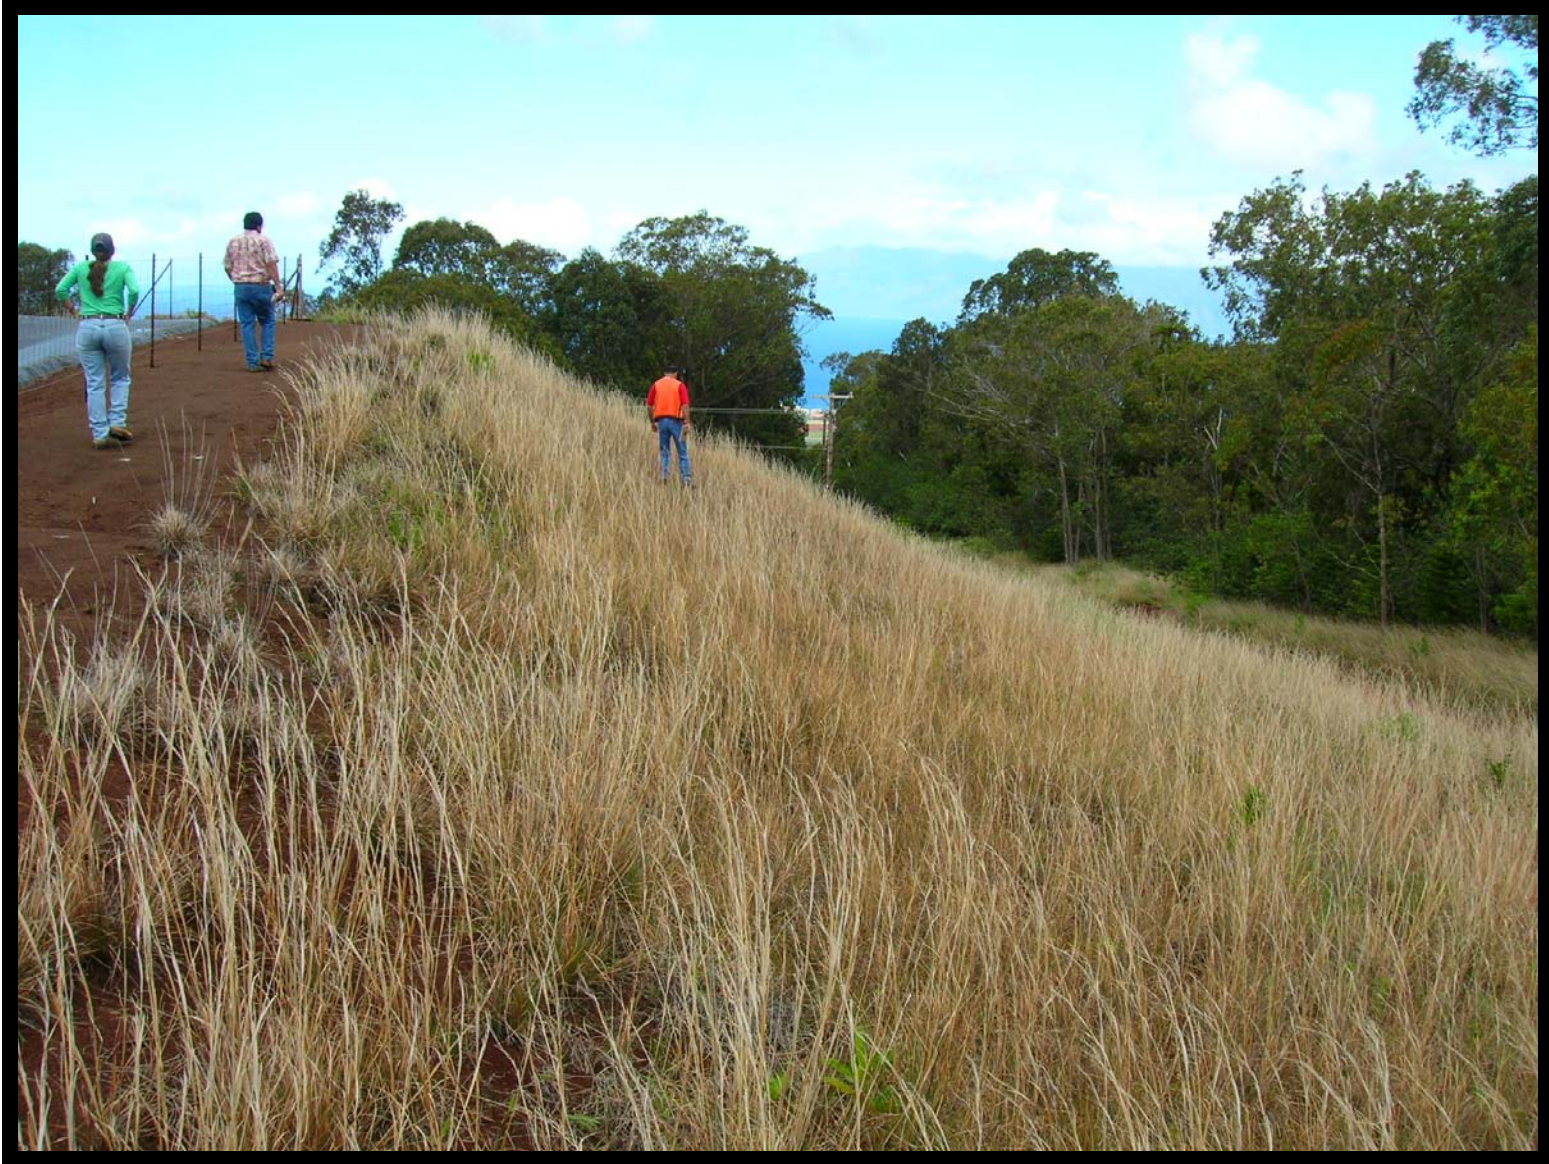
132 downstream slope

The downstream slope was in fair condition due to the presence of minor seepage, tall grass and bushes.

Sinkholes and cracking were not visible on the downstream slope, however the slope was not entirely visible.

Seepage was visible about half way up the downstream toe and was observed to be less than 0.5 gal/min. This seep dries up during dry periods.

- a. The downstream slope appeared to be in fair to poor condition and requires corrective action.
- b. Seepage/Ponding water was observed. Monitor and conduct further investigation to locate the source of water and extent of any possible hazardous or developing condition.

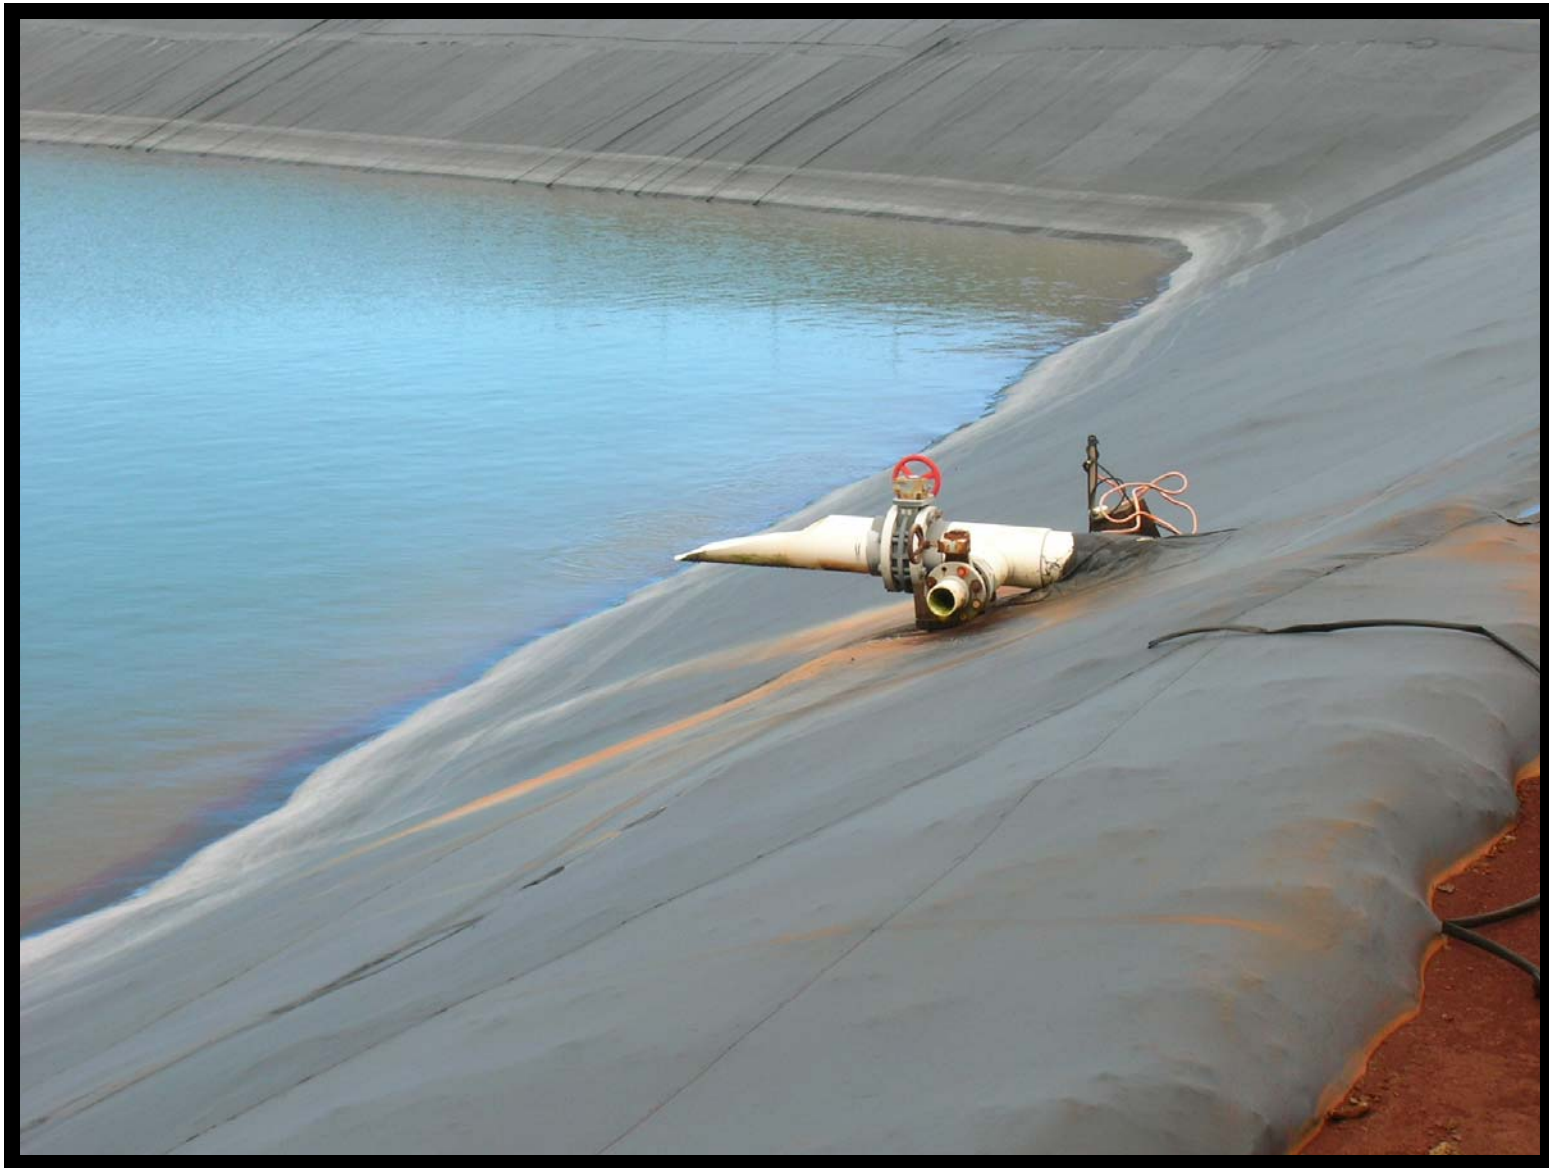
132 inlet

There are two inlet pipes consisting of a 10-inch and 6-inch PVC pipe. The intake has the ability to be shut off or diverted away from the reservoir during periods of heavy rains. This is done manually.

- a. The intake works were not tested.
- b. The intake works appeared to be in satisfactory condition, no corrective actions are required at this time.

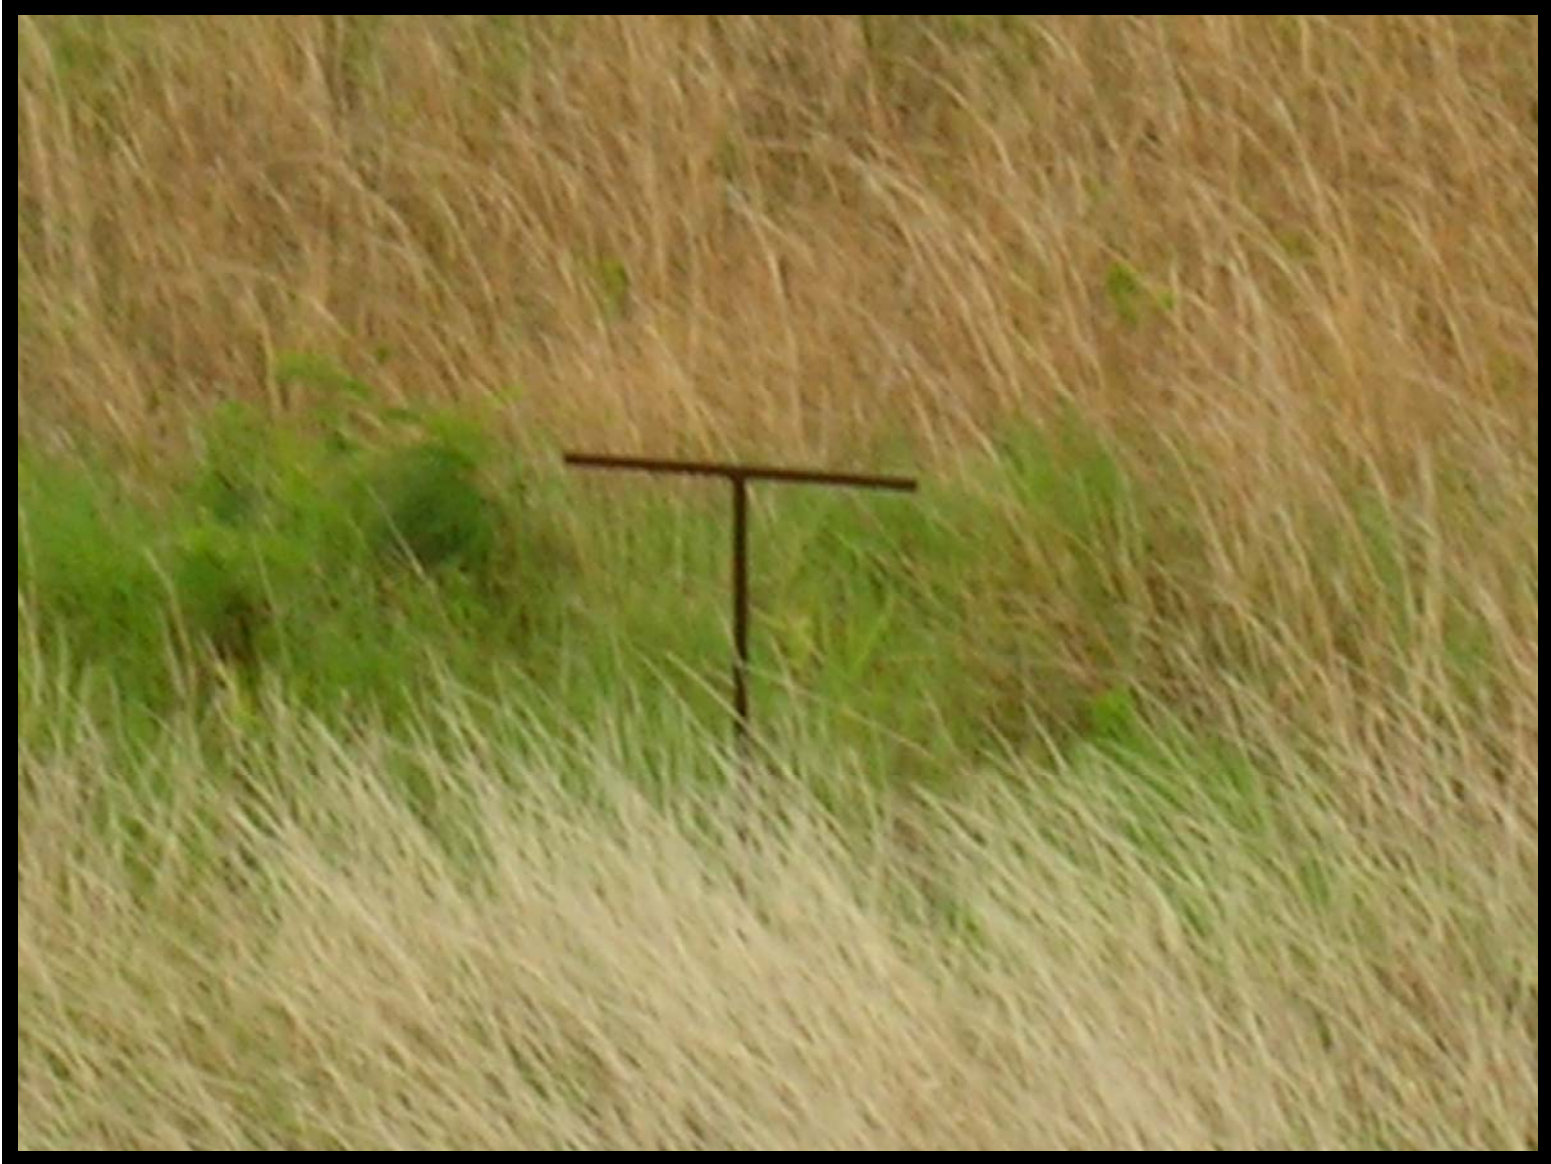
132 outlet valve

Not inspected in detail, not tested. The outlet works was controlled via a valve on the downstream side of the dam. Seepage was not observed flowing near the exit of the outlet works from the dam.

- a. The outlet works were not tested.
- b. The outlet works appeared to be in satisfactory condition, no corrective actions are required at this time.

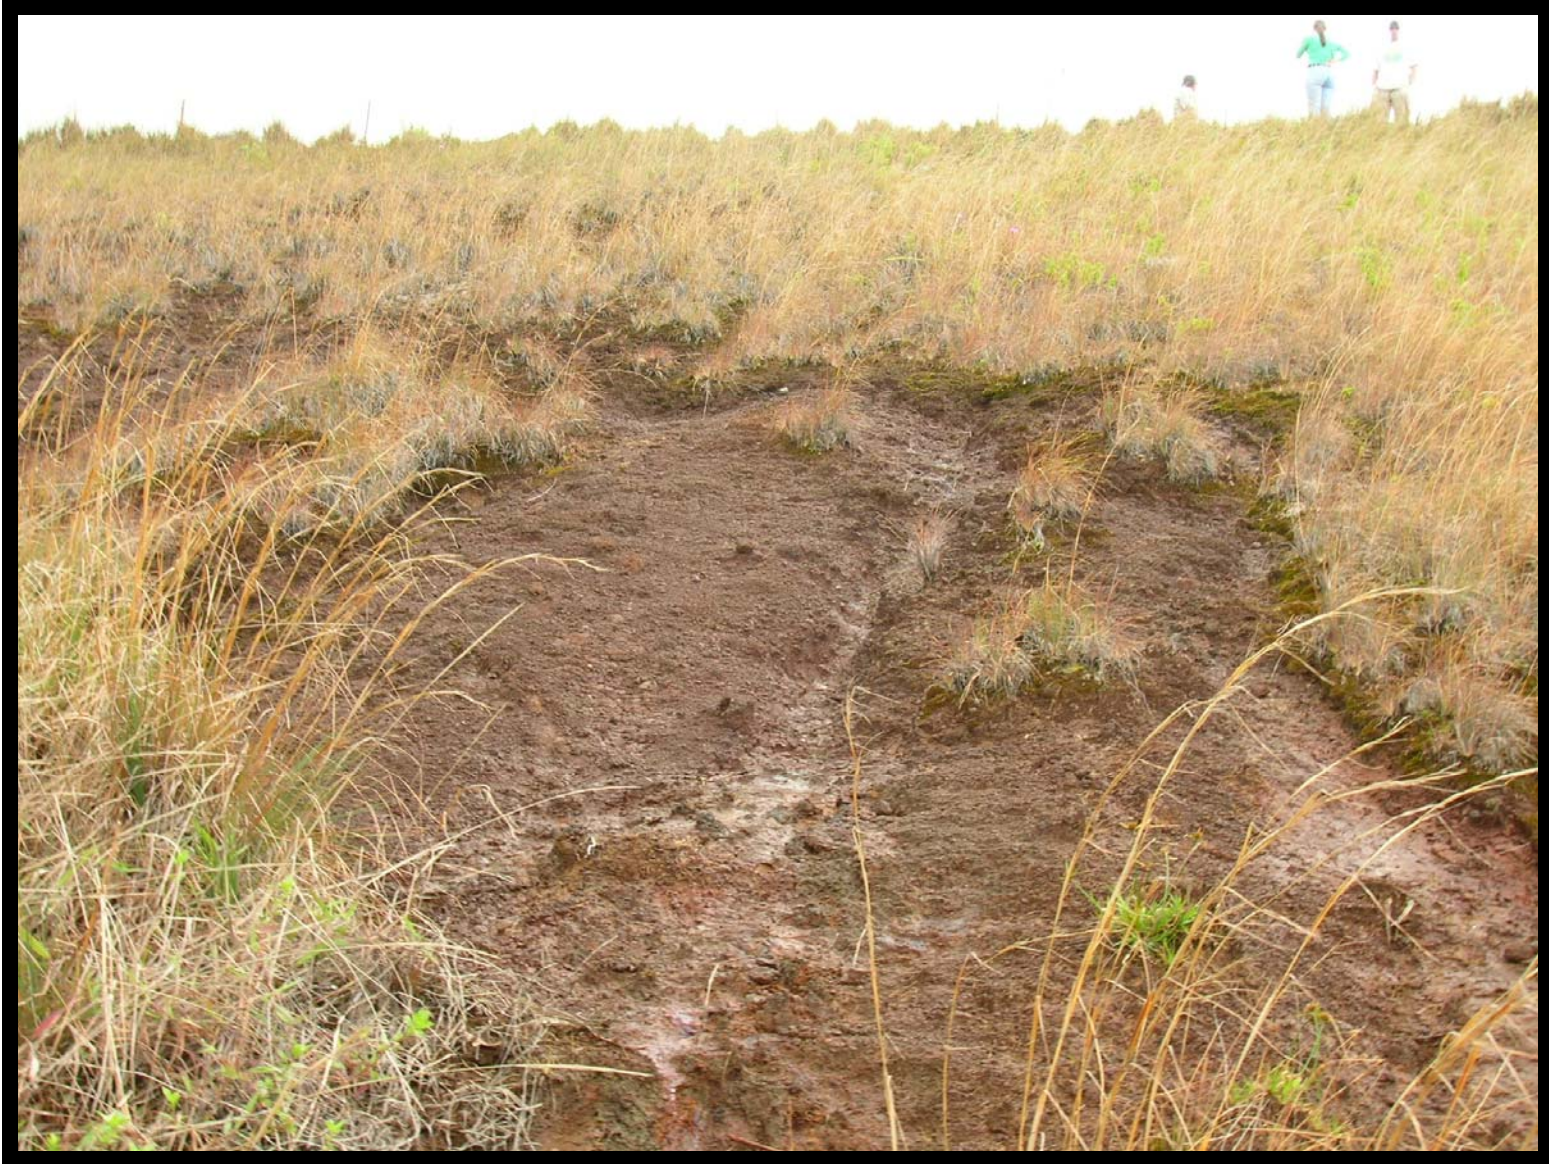
132 seep - small seep in downstream slope

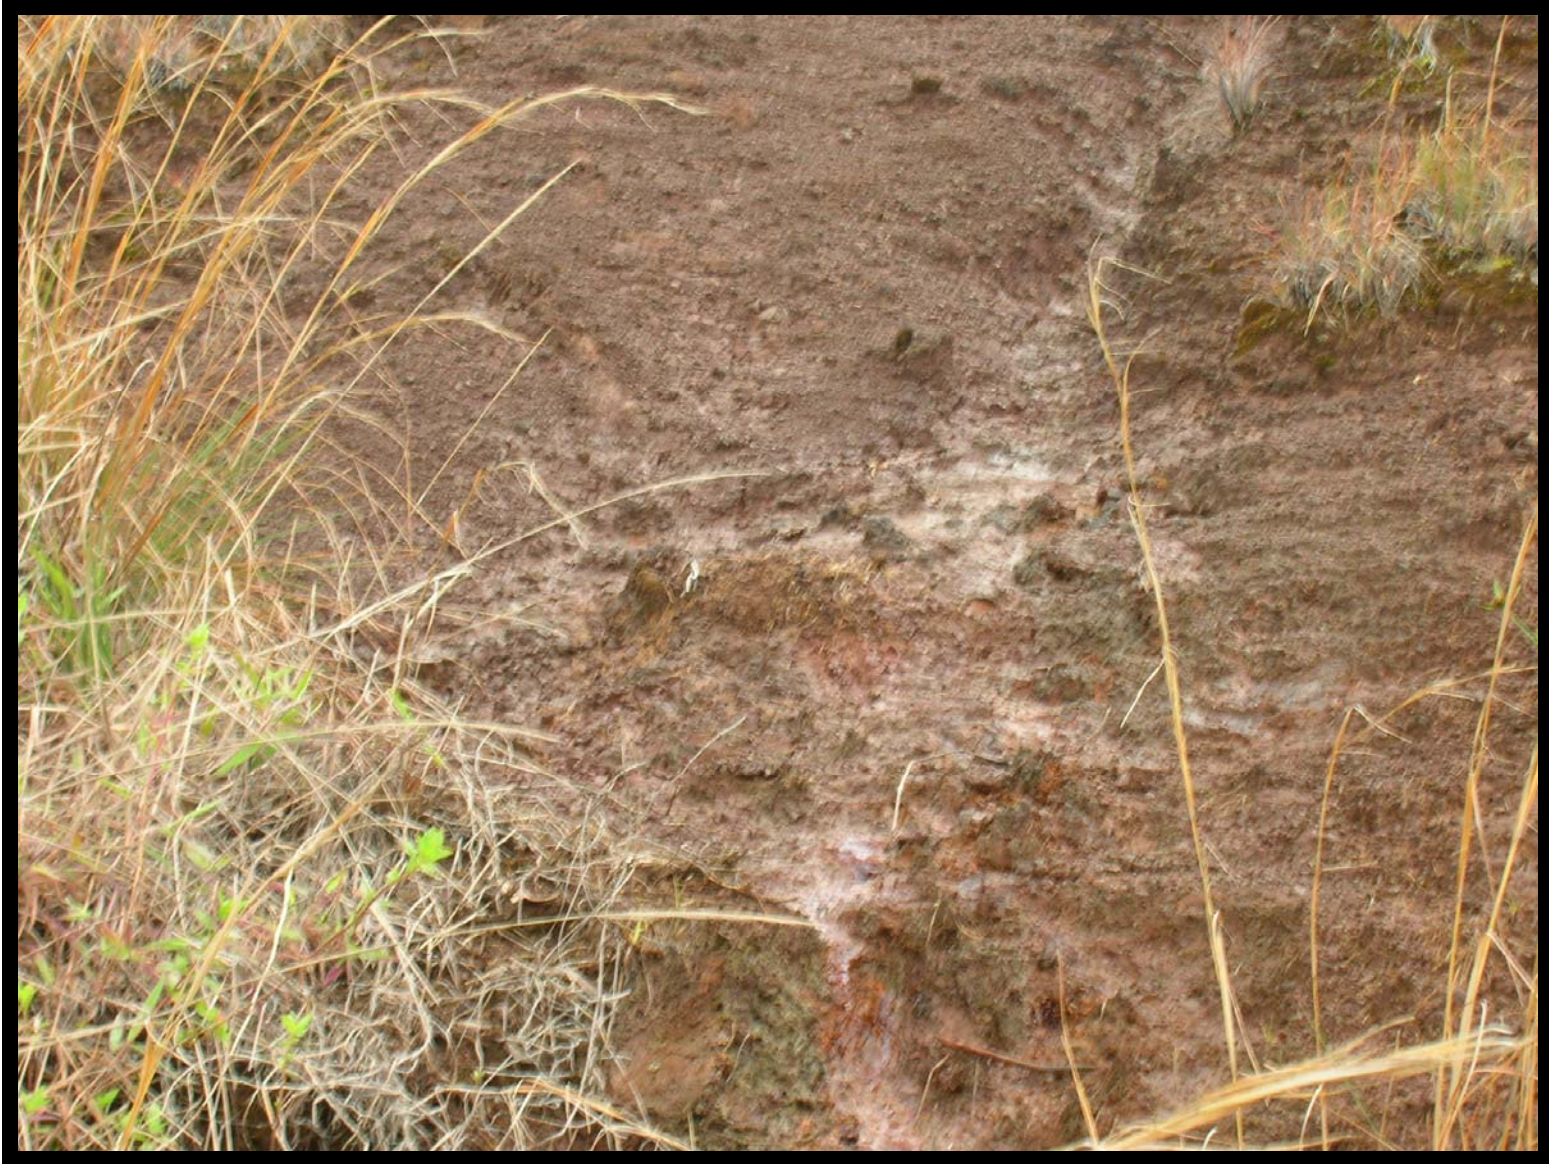
132 seep 2 - small seep in downstream slope

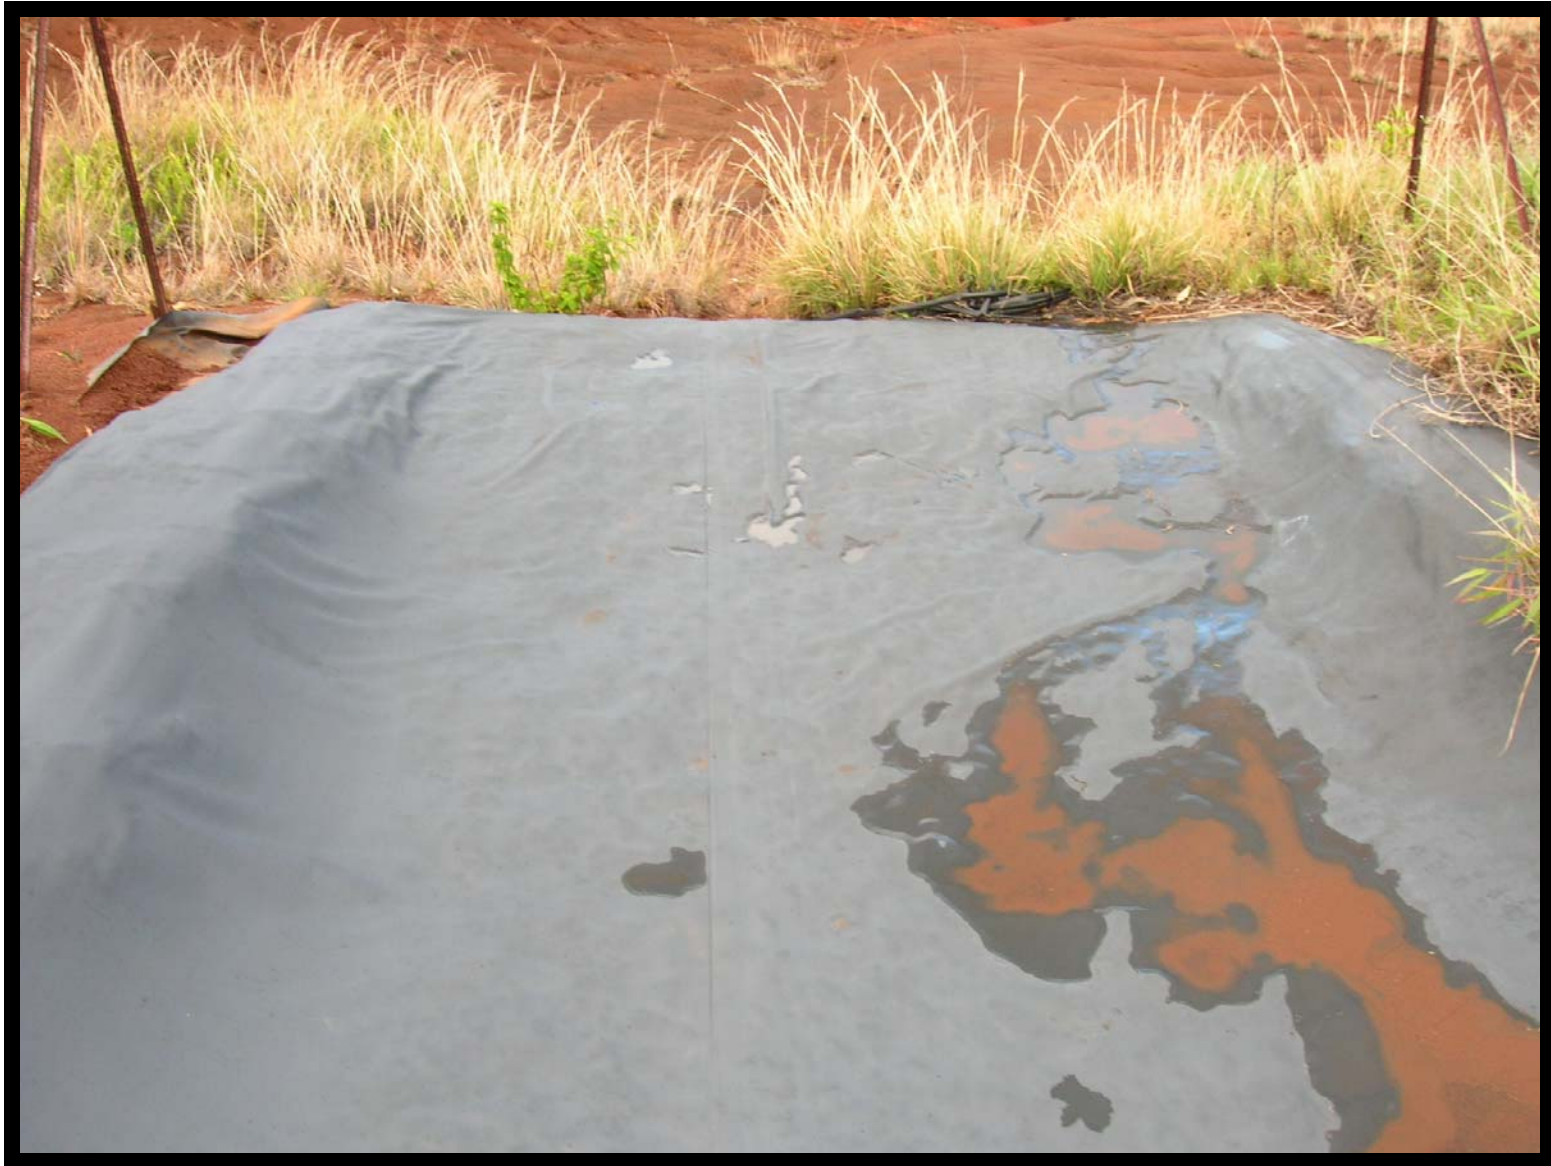
132 spillway

There was minor erosion observed near the spillway. (Small gully)

- a. The Spillway appeared to be in satisfactory condition, no corrective actions are required at this time.

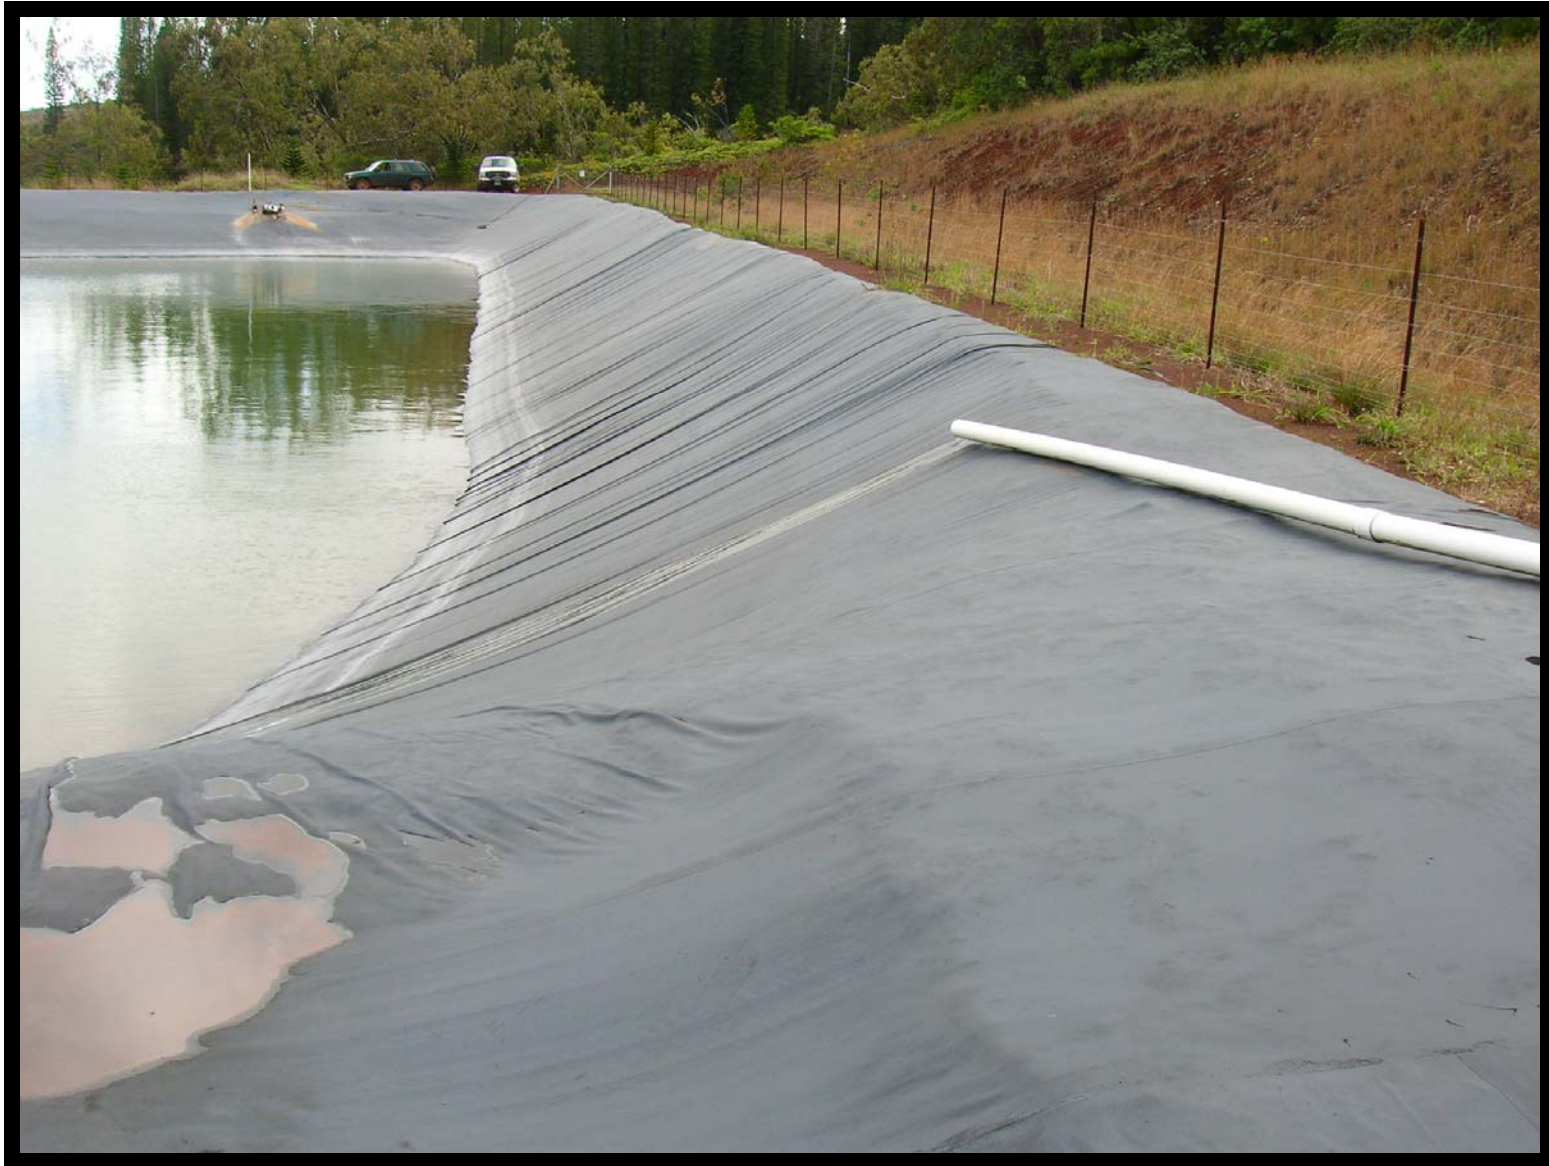
132 upstream slope

The upstream slope was 1 to 2.

The slope is lined with HDPE.

Cracks were not observed; the slope was not entirely visible.

- a. The upstream slope appeared to be in satisfactory condition and does not require corrective action.
